Diplexer MW Wavre 621 kHz & 300 kW, 540 kHz & 100 kW

Technical report

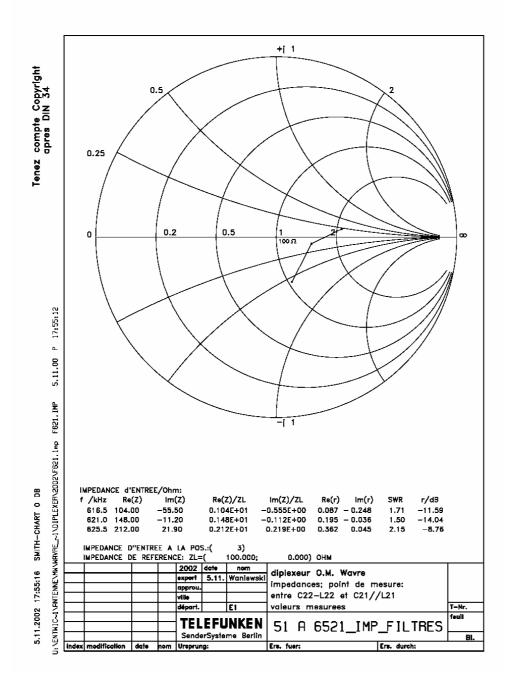
Drawing 51 A 6521_IMP_FILTRES shows the impedances with reference to 100 ohms:

- Due to the modification of the antenna the change of impedance at the point of the series filter L22-C22 causes an increase of voltage by 5 % across the series filter.

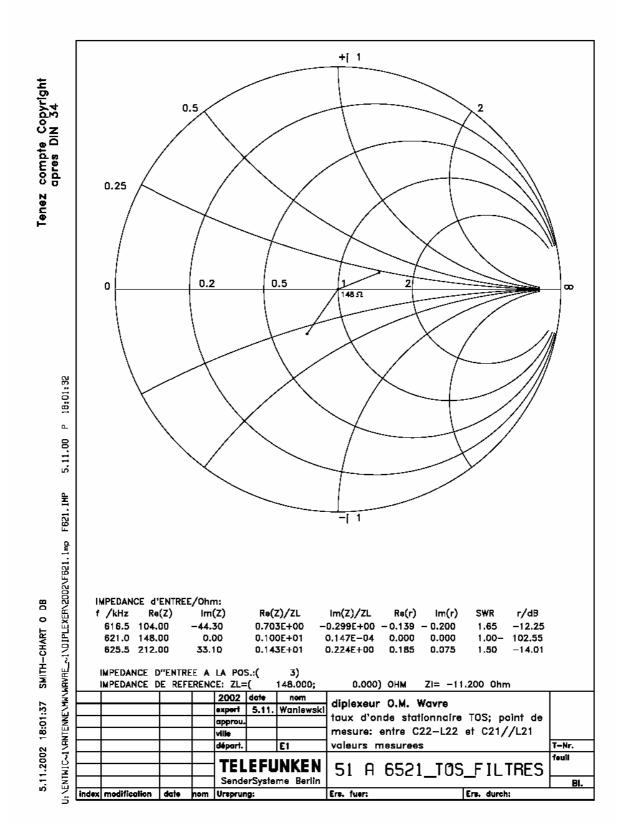
Drawing 51 A 6521_TOS_FILTRES shows the standing wave ratio with reference to the impedance of the centre frequency:

- The bandwidth for the frequencies +/- 4.5 kHz remains nearly the same compared to the situation in 1992.

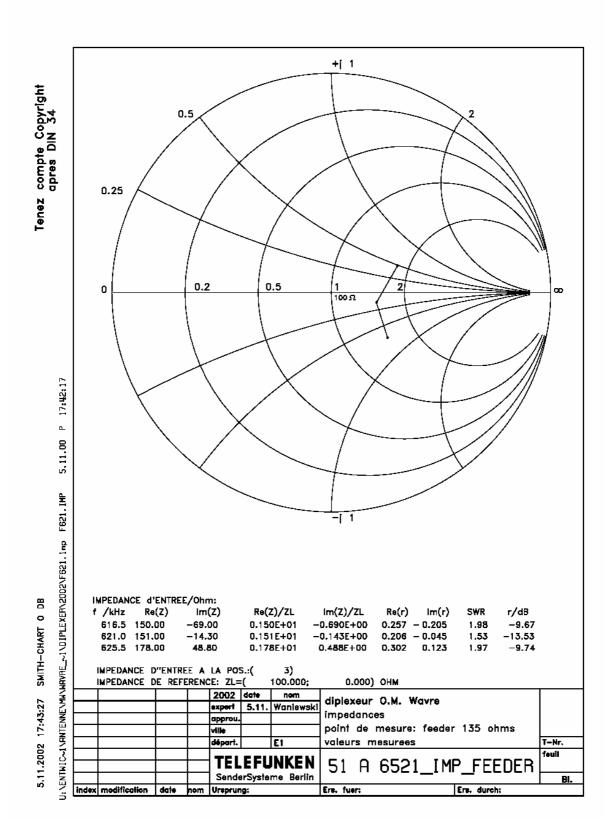
Drawing 51 A 6521_TOS_ FEEDER shows the standing wave ratio with reference to the impedance of the centre frequency.

- The bandwidth for the frequencies +/- 4.5 kHz remains nearly the same compared to the situation in 1992.

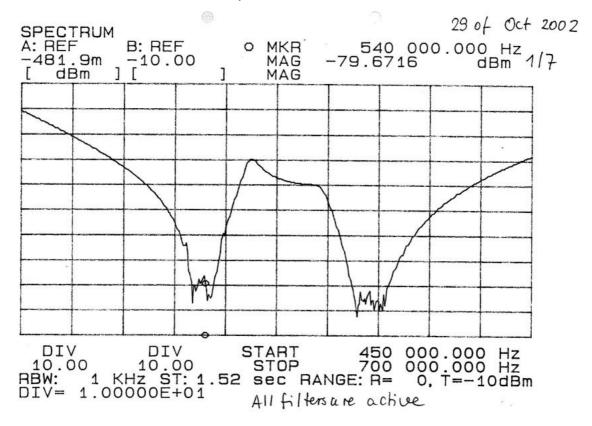
- Plot 1 of 7 shows the spectrum when all filters are active.

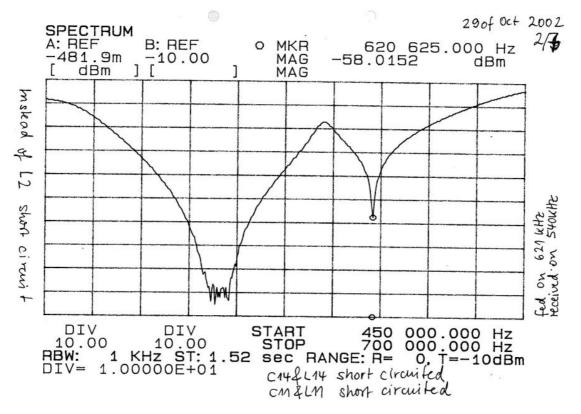
- Plot 2 of 7 shows the spectrum when all filters except C14&L14 and C11&L11 are active.

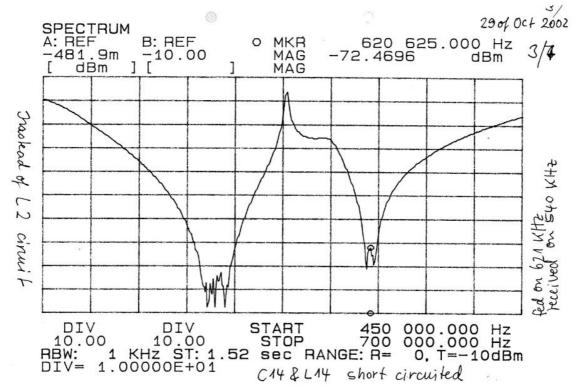
- Plot 3 of 7 shows the spectrum when all filters except C14&L14 are active.

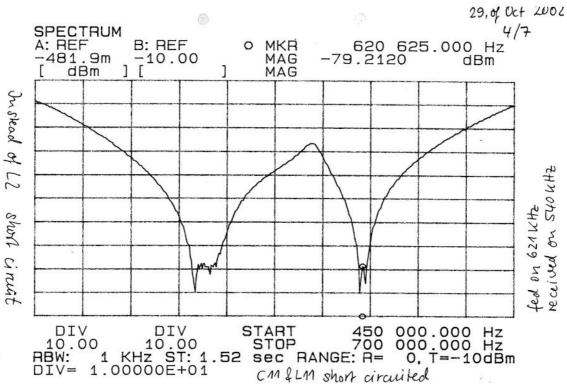
- Plot 4 of 7 shows the spectrum when all filters except C11&L11 are active.

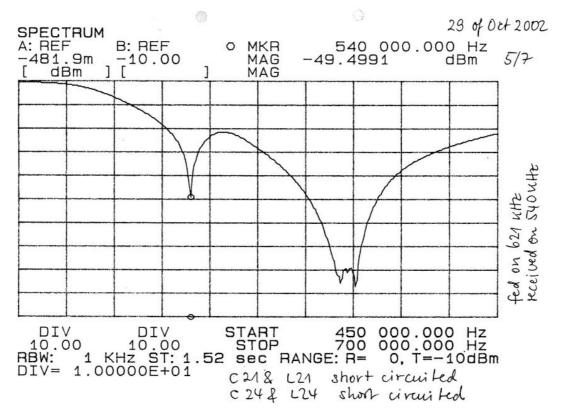
Plot 5 of 7 shows the spectrum when all filters except C21&L21 and C24&L24 are active.

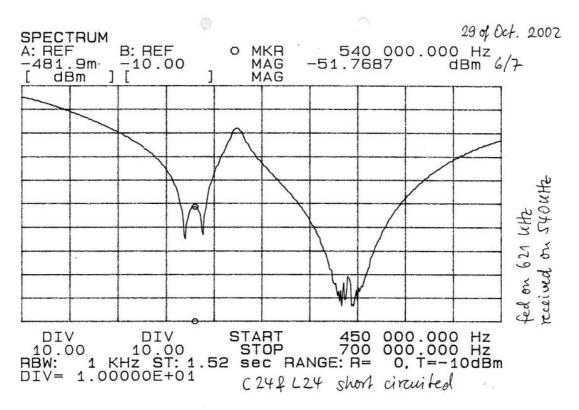
- Plot 6 of 7 shows the spectrum when all filters except C24&L24 are active.

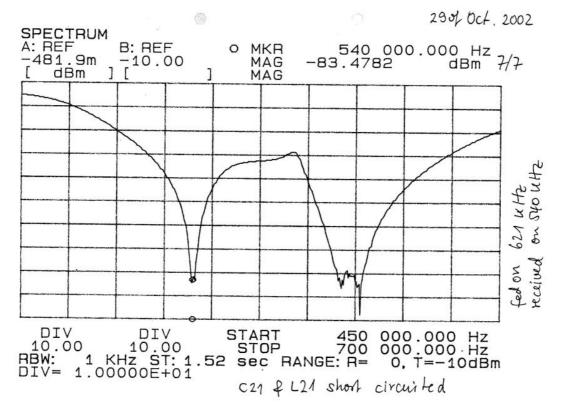
- Plot 7 of 7 shows the spectrum when all filters except C21&L21 are active.

- The plots show that the tuning of the filters represent the optimum and that it is not changed compared to the situation in 1992.
- 4. Power tests
